East Birch Creek Aquatic Ecosystem Restoration Pilot Rock, Oregon

Environmental Assessment

**East Birch Creek
Aquatic Ecosystem Restoration**

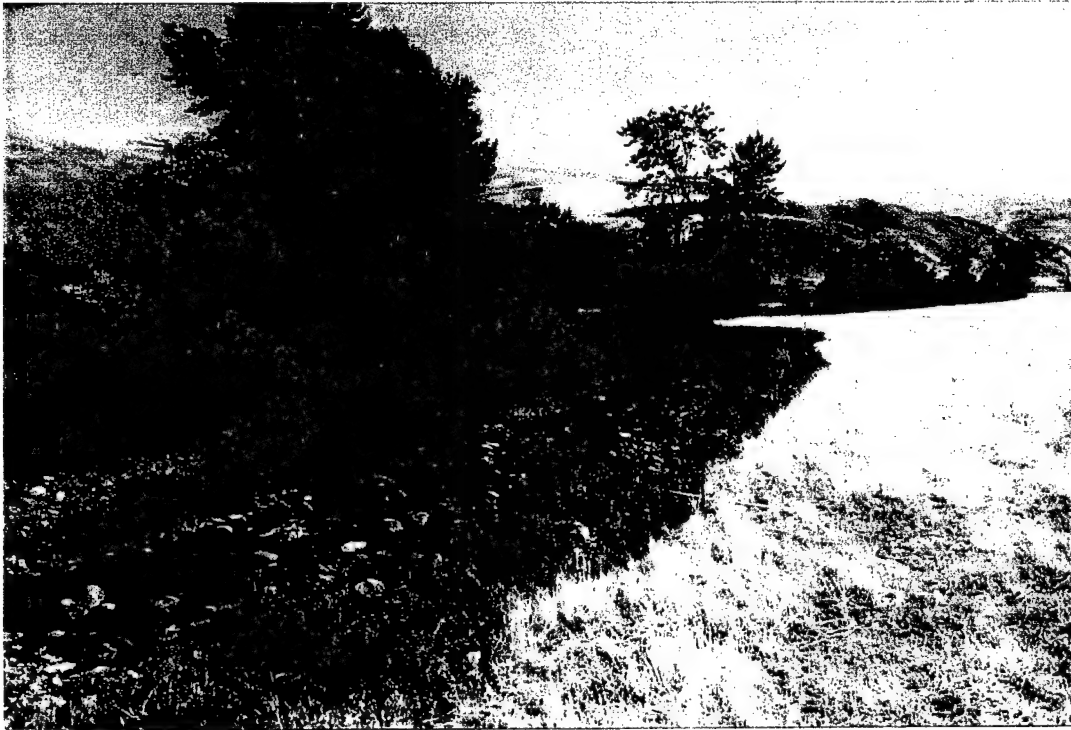
Photo 5 - Vegetation Reestablished and Streambed Armoring (Reach-5)

Reach-5 contains the final approximate 500 feet (150 meters) of the project. Reach-5 varies between type B and type C cross section geometry. This portion of the streambed is 7-8 feet (2 meters) below the ancestral floodplain. The stream meander pattern/sinuosity is altered by the ranching and agricultural uses and has a pattern typical of type B streams (straightened rather than meandering) but, would be a class C stream in undisturbed situations (indicated by valley type, valley slope, etc.). Much of this reach is approaching a stable condition. The boulders and cobbles are beginning to form an armor layer over the thalweg and vegetation is covering/stabilizing the bars (see Photograph 5).
